## The restoration works: techniques and interventions

### *The atrium and the elevation on Strada Nuova*

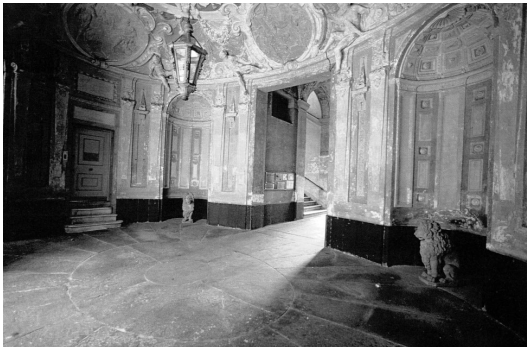
1. Atrium of palazzo Nicolosio Lomellino in Genoa, before restoration

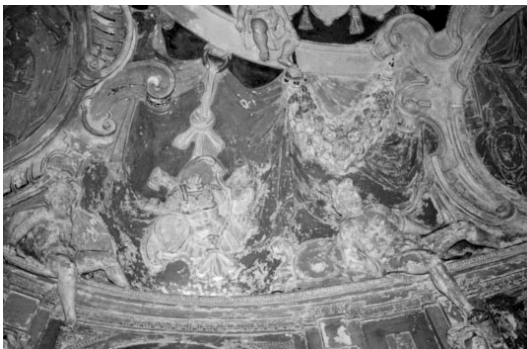
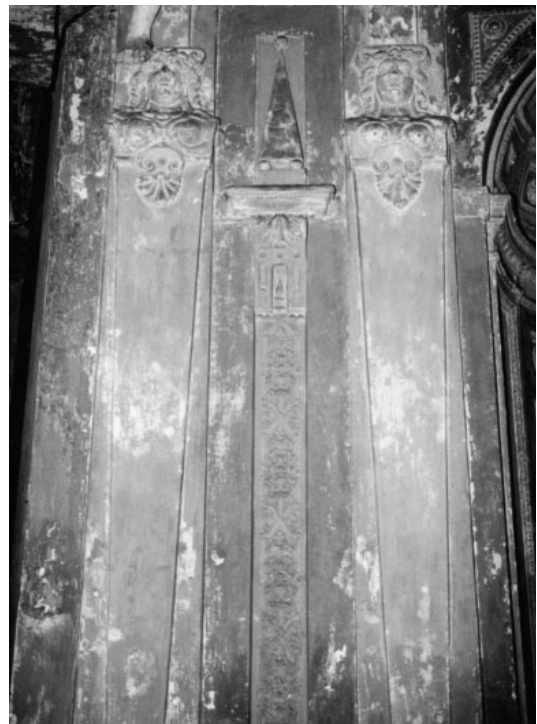
The works started in March 2000, with the recuperation of the atrium’s many coloured decorations in stucco: this elliptically designed room, with the minor axis perpendicular to the facade, enjoys a view of the entrance hall and of the subsequent courtyard with the nymphaeum, creating a sort of link between Strada Nuova and the Montalbano hill situated at the back, where the terraced hanging garden was formed and is still present (fig. 1). The strong scenographic impact of the oval atrium presents a decorative context containing historical scenes on medals, niches side by side with couples of herms and obelisks on elaborate cornices: the reliefs which overhang the most are made up of large, round figures positioned on cornices (figs. 2-3).

2-3. Detail of the atrium of palazzo Nicolosio Lomellino in Genoa, before restoration.

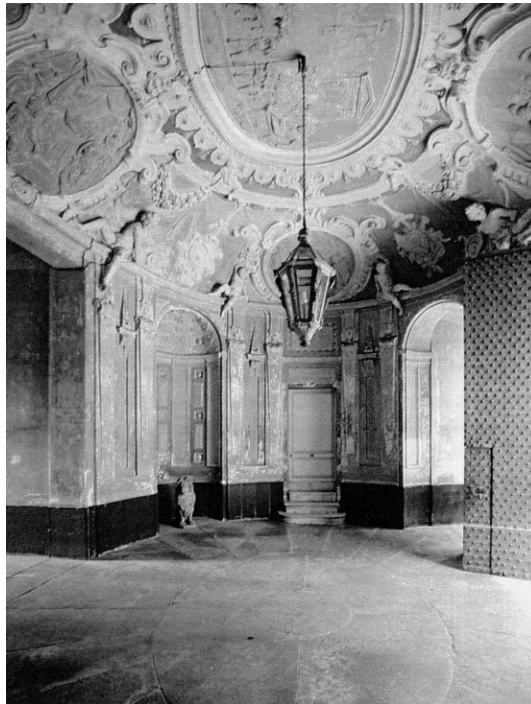
culars and details and hiding from view the original colour: the most recent layer, commissioned by Andrea Podestà in the second half of the XIX century, is not very understandable, blackened and partially detached (fig. 4). Below the added layers, removed with scalpels, a difference was noted in the treatment and finishing of the surface, studied and elaborated in such a way to obtain specific light and shadow effects, using soft colour shading and diverse light absorption on the surface, depending if the latter is rough or polished; the greys treated with half tones change according to the way the characters are observed, the pink of the humans is transparent and vibrant, the light blues enhanced by the matching of diversely ground pigments.

4. Atrium of palazzo Nicolosio Lomellino in Genoa, before restoration.

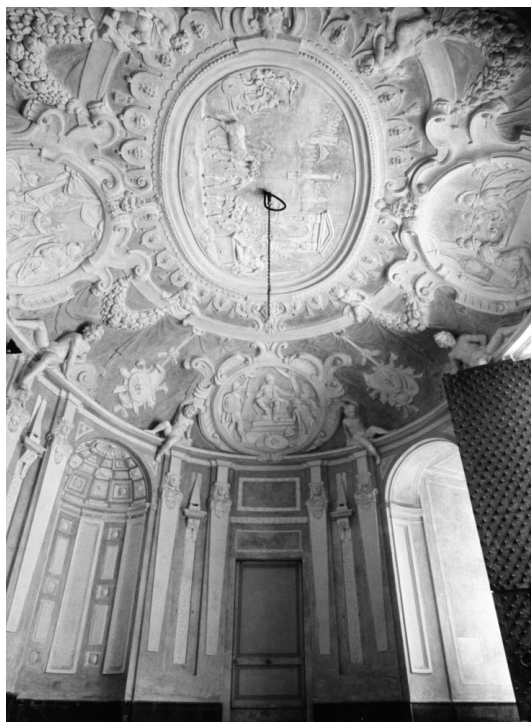
5. Atrium of palazzo Nicolosio Lomellino in Genoa, after restoration.

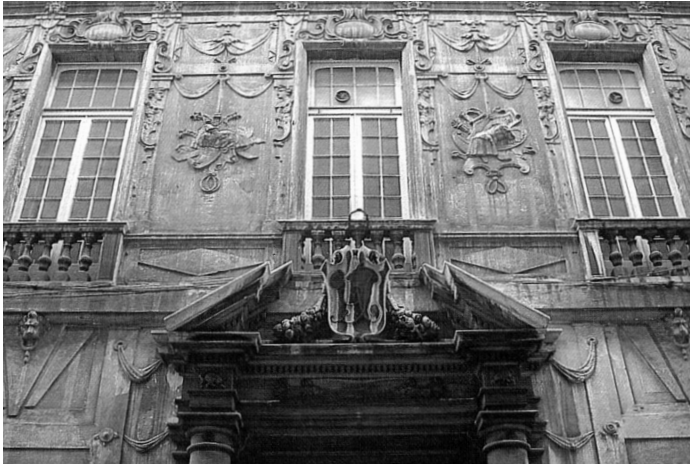
ch inclement weather ). As Federico Alizeri said, the stucco reliefs in the atrium and on the elevation of palazzo Lomellino, excluding the repeated colourings and the inevitable reconstruction due to structural changes, especially on the facade, have maintained a remarkable material compactness and cohesion (fig. 6).

6. Elevation of palazzo Nicolosio Lomellino in Strada Nuova in Genoa, before restoration

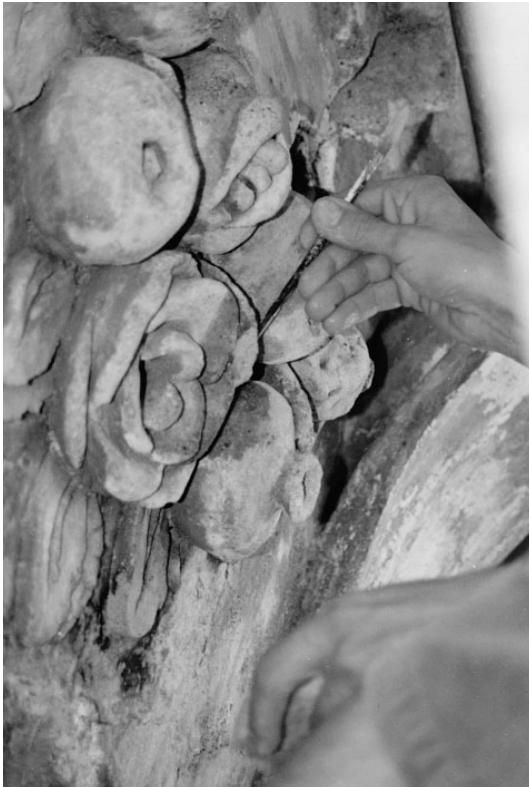
7. Detail of the stucco decoration on the elevation of palazzo Nicolosio Lomellino in Strada Nuova in Genoa, during the restoration.

tachments were found, especially close to the stringcourses, due probably to vibrations caused by bomb splinters that struck the facade, and by the infiltration of rainwater. Further deterioration was caused by the almost uniform spreading of a yellow orange tempera which, once penetrated in to the first surface level had provoked blotching: such a problem became more tenacious when the surface was already compromised by the loss of its smooth glazing (fig. 7).

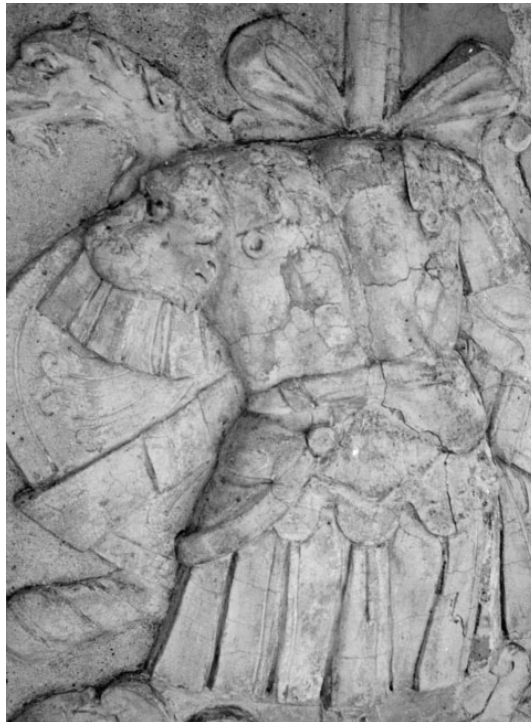
8. Detail of the stucco decoration on the elevation of palazzo Nicolosio Lomellino in Strada Nuova in Genoa, during the restoration.

Following the re-integration with lime based mortar of the gaps found following the removal of the incorrect stuccoes, with the aim of the restitution of the alternating colours neutral-slate grey, the trompe l'oeil were treated with a glaze of colours with suitable pigments (fig. 8). All the perspective's stone tablets were cleaned using the "jos" system, that is to say with jets of nebulised water at low pressure (up to 0,2/0,4 atm.) mixed with extremely fine calcium carbonate powder, and the marble surfaces of the portal and of the balustrades were protected with a polymeric single component transpirant.

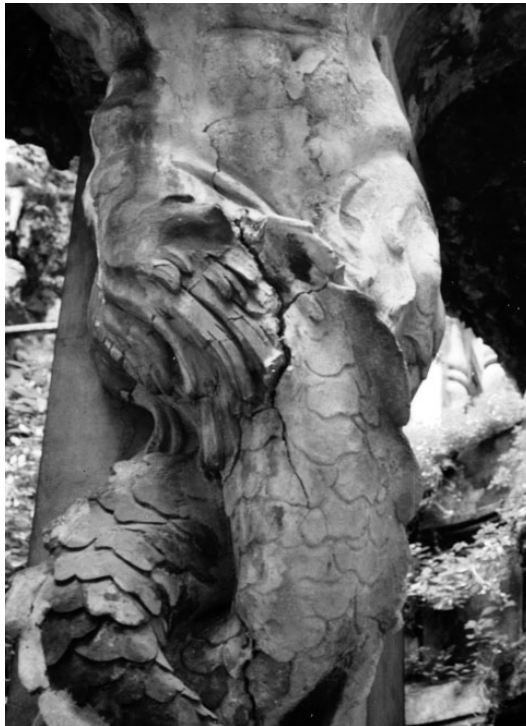
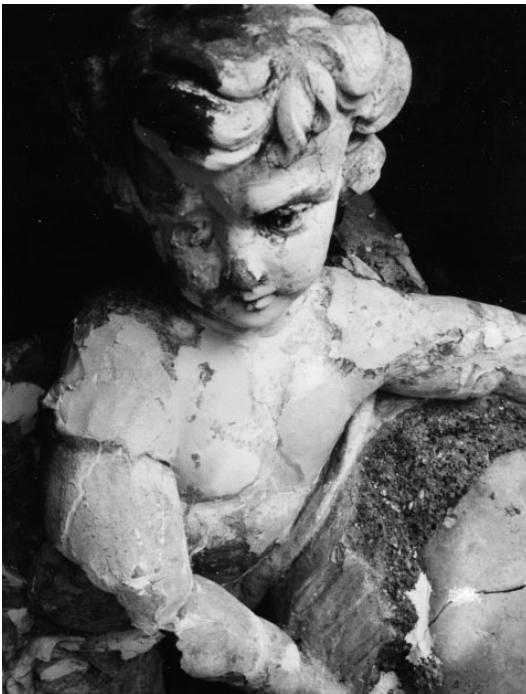
Already by observing the facade, through the view offered from the atrium, it is possible to distinguish at the end of the court, the two unique plastic tritons of the nymphaeum by Domenico Parodi: this architectural pluri-material structure creates a scenic perspective link in a very limited space that involves the palazzo and the Italian garden above (figs. 9-10).

9-10. Detail of the nymphaeum of palazzo Nicolosio Lomellino in Genoa, before restoration

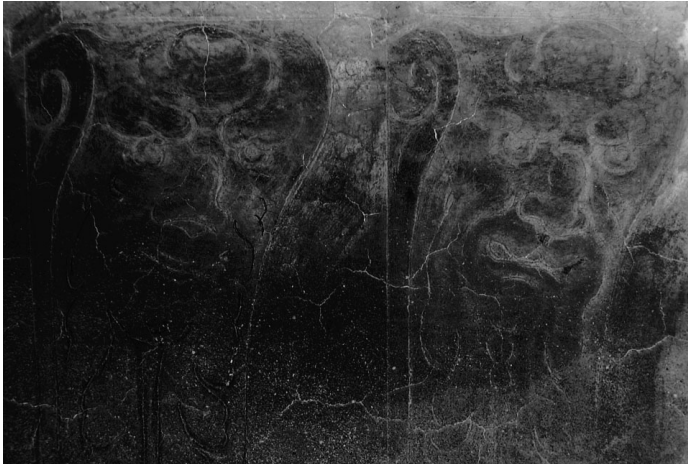
12. Residual decoration of the internal elevations of palazzo Nicolosio Lomellino in Genoa

Observing the surface during the survey of the state of deterioration, the non-homogenous nature of the plaster was immediately noticed, largely impoverished by atmospheric agents, except in the zones protected by the eaves and string courses, where the painted decoration was still present and well preserved; the base, as then confirmed by the scientific investigations, was covered with a lime and sand mortar (including other substances of different nature and granulometry), and by a thinner layer of ground terracotta. The plaster, spread over in days and by scaffolds, left a residual pictorial film (strips of decoration and colour in the areas protected from the washing away), very compact, with lime colours, spread on a still quite fresh base (fig.11).

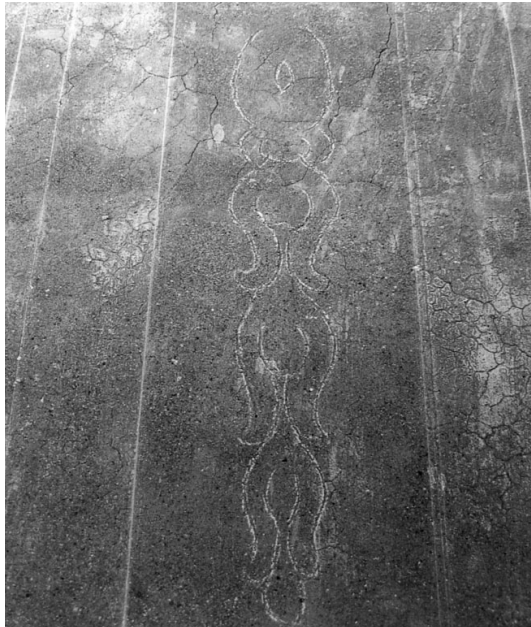
13. Incision with skimming light of the internal elevations of palazzo Nicolosio Lomellino in Genoa

through a graphic plan of all of the incision lines present, extremely evident close up or with the use of a skimming light (fig. 12). The entire decorative display, re-done with a lime based colour glaze correctly pigmented; the surface was then treated with silosanic water repellent for protection. Likewise the process on the elevation surfaces facing palazzo Grimaldi (Tursi): here the decorative repertory was entirely re-done, documented by the historical photo retraced at the Photographic Studio of Palazzo Rosso, and totally re-designed from the signs carved on the plaster (fig. 13).
